Vizcaya, Longboat Key, FL

condominium with aluminum railing systems, windows and door frames.

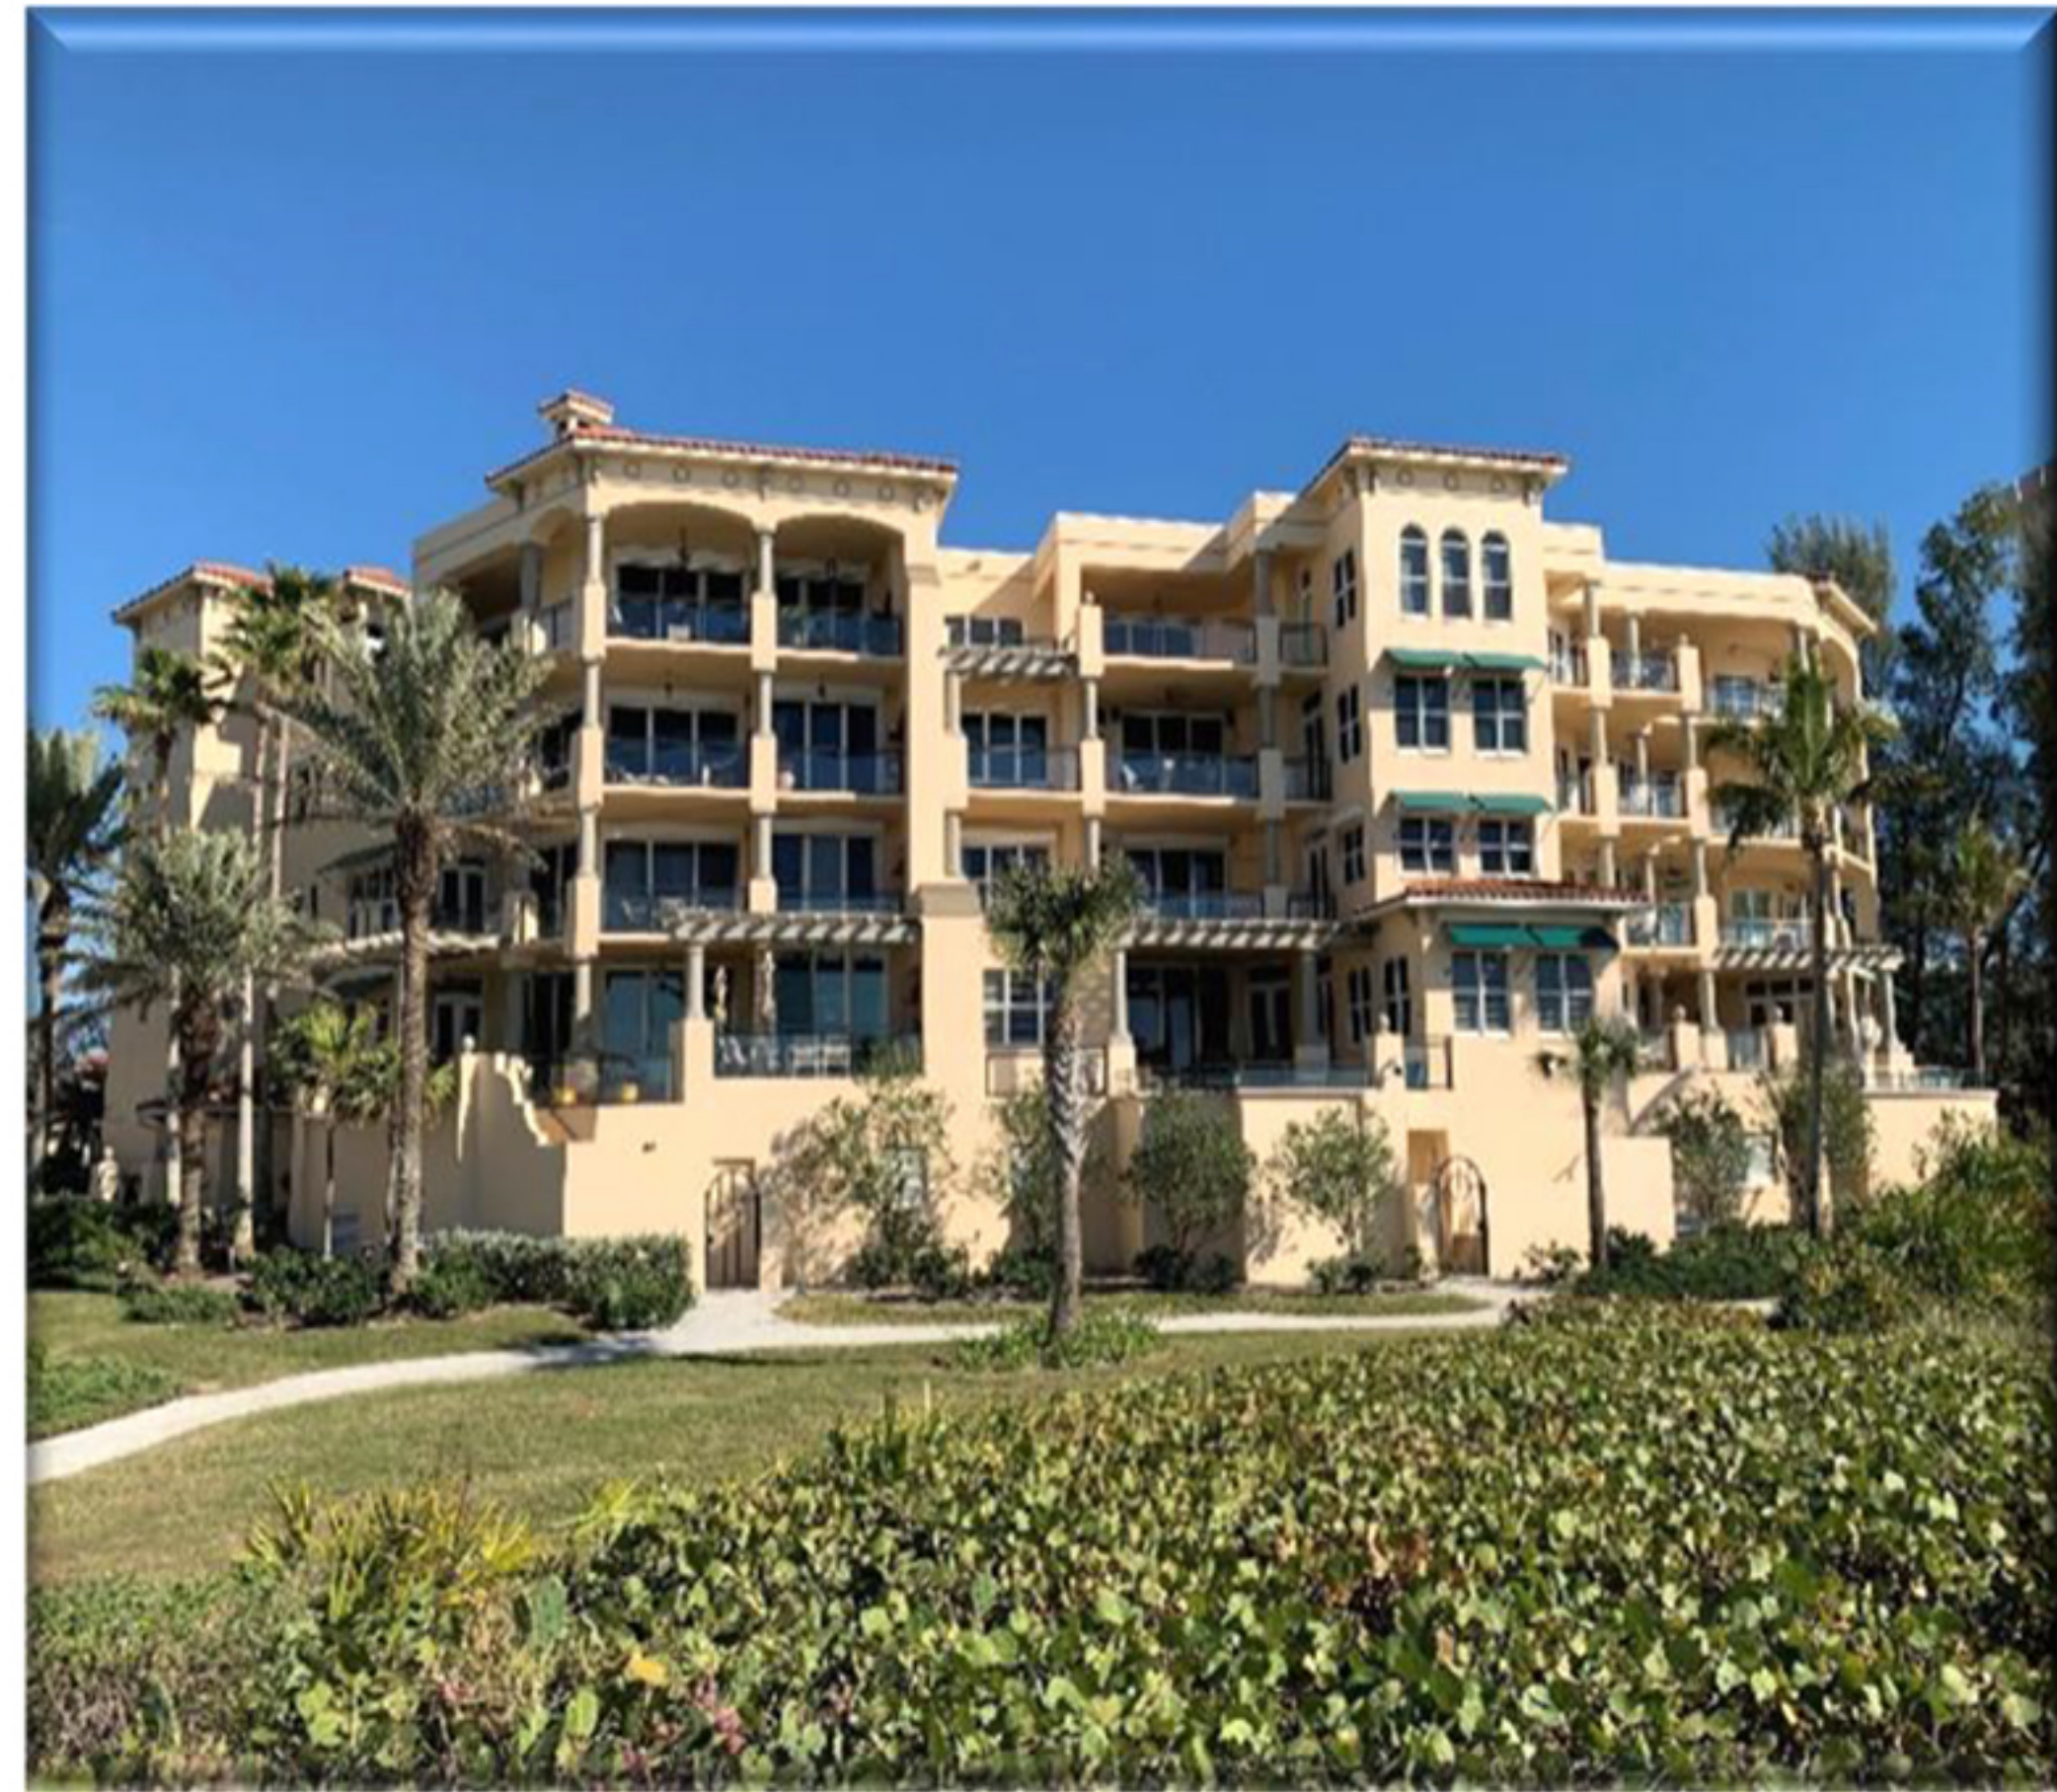
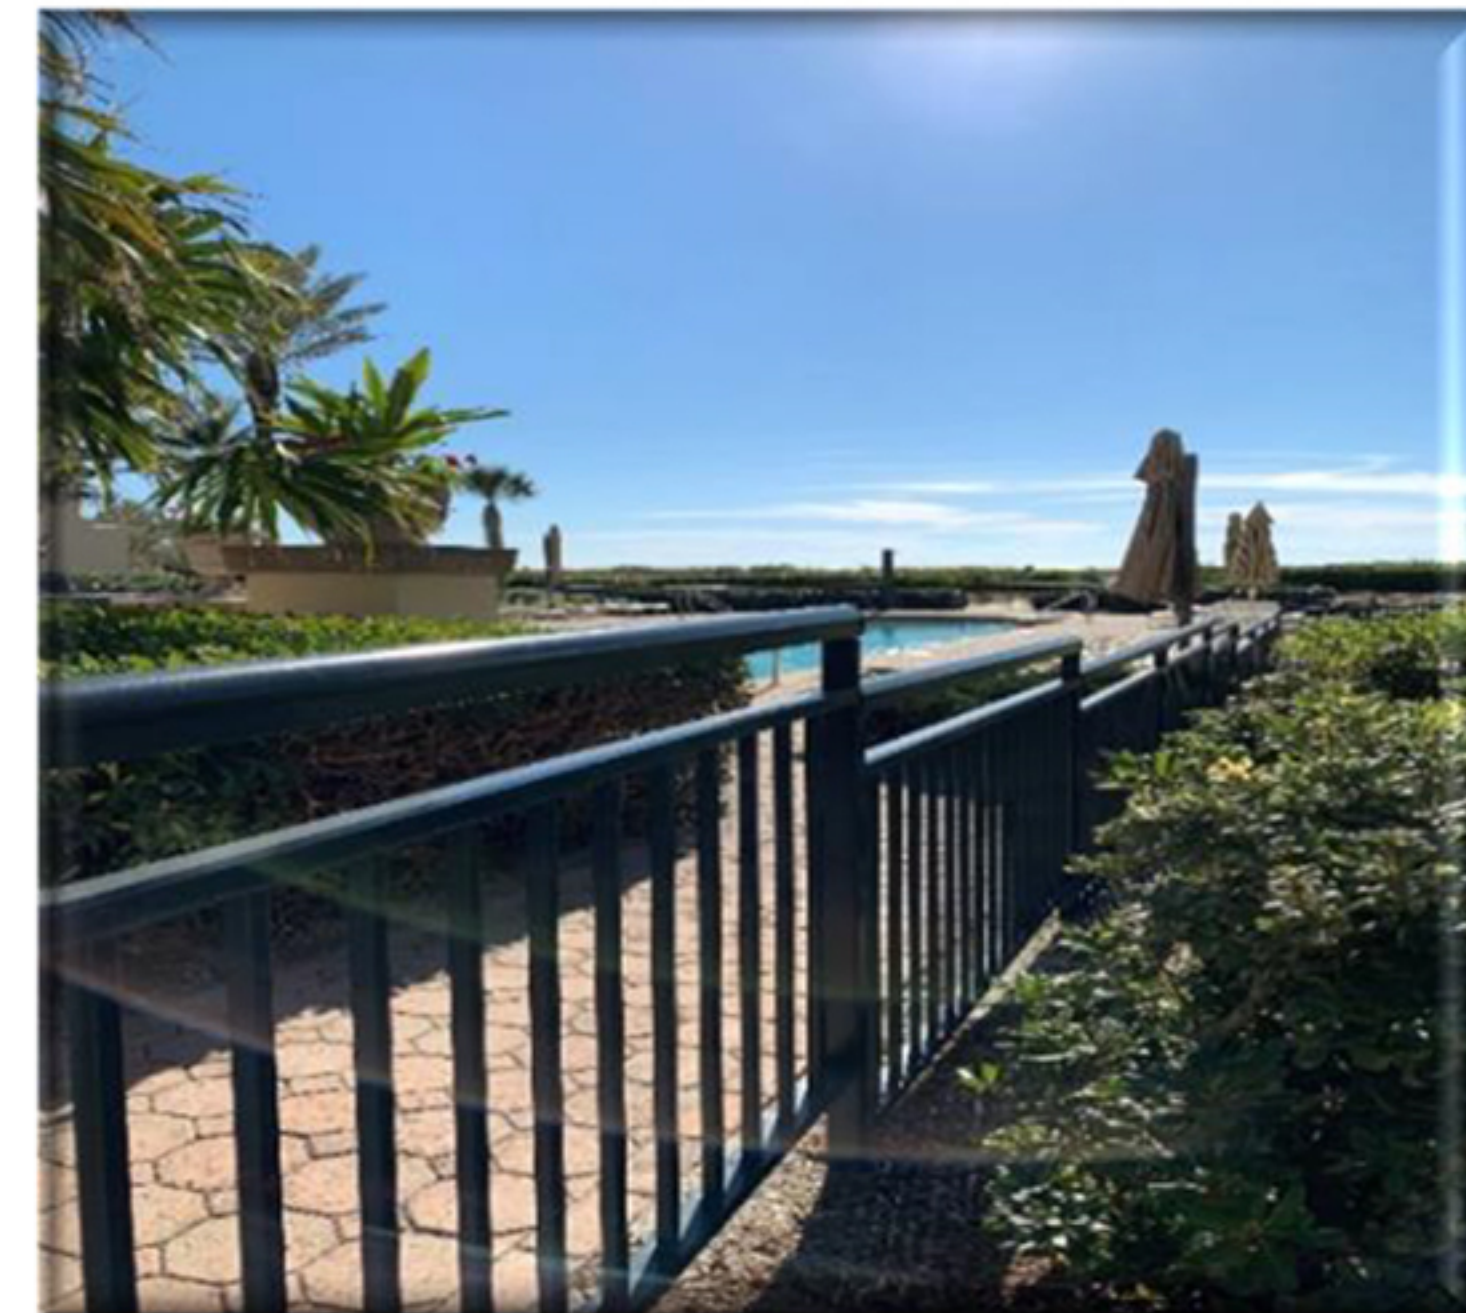
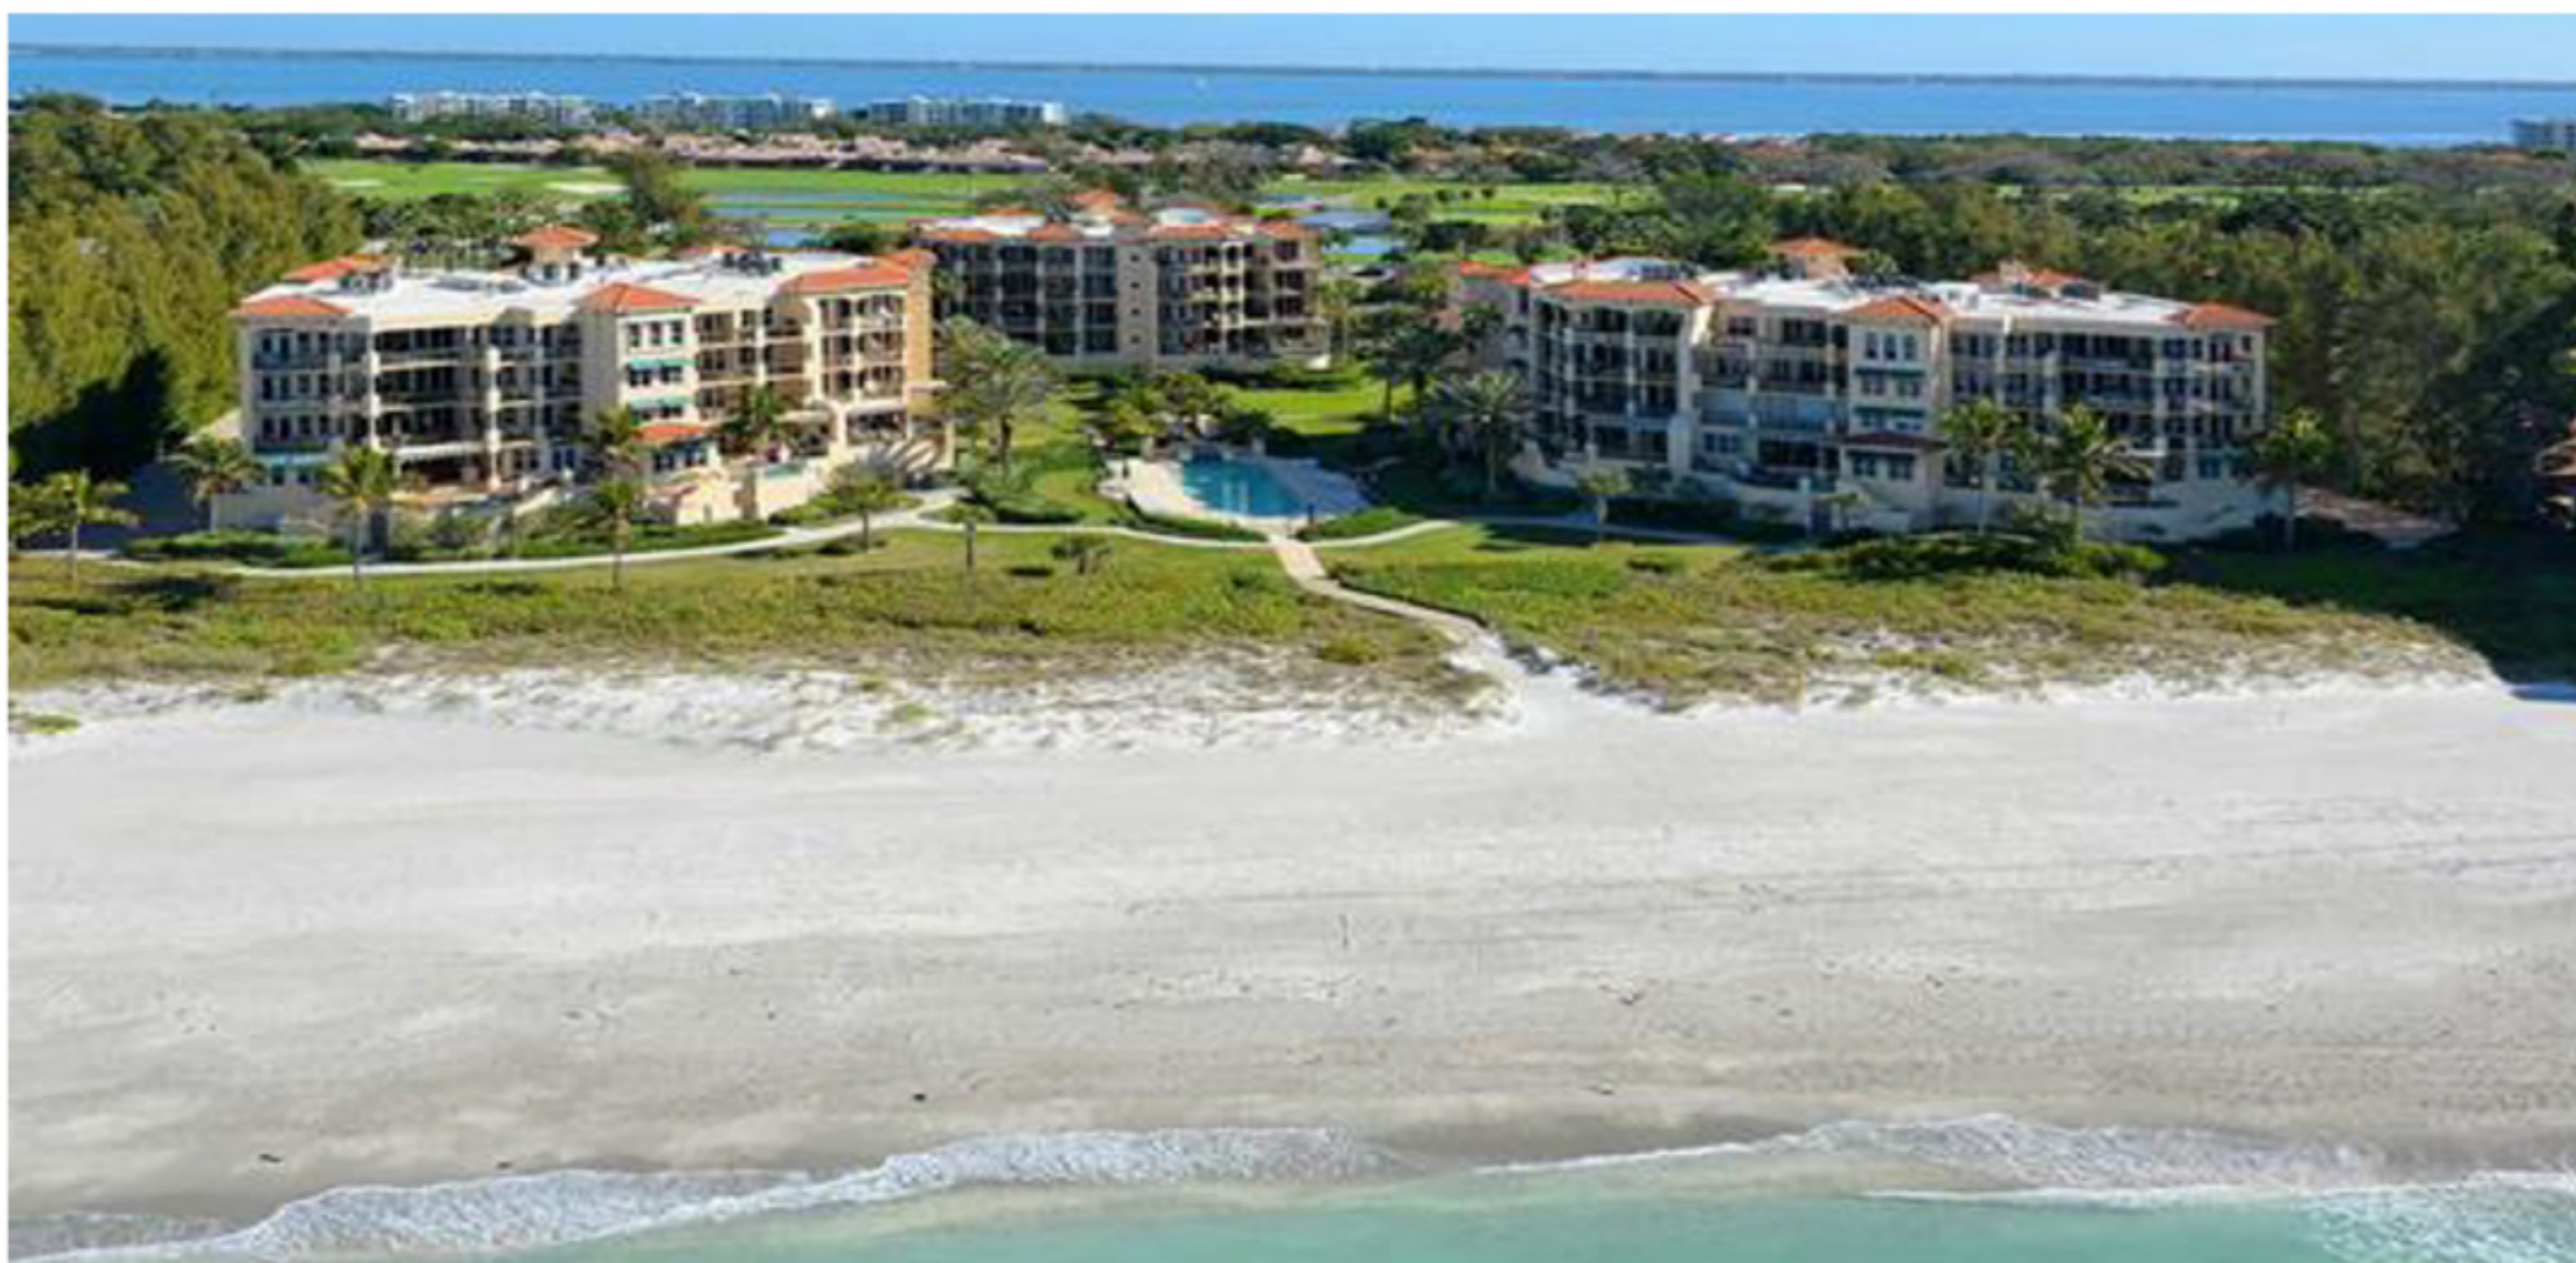
The salt water environment degraded the existing coatings causing corrosion and color fading and compromised sealant integrity.

Complete sealant removal and replacement to restore water-tight building envelope. HVLP painting system applied to all metal railings, doors and frames to stop further corrosion and restore aesthetic appearance of aluminum.
